Manhole Inspection Summary

Manhole # S31A__011MH

Insp Date: **12/21/07 10:19 AM**

Location Address: **583 ORCHARD ST**

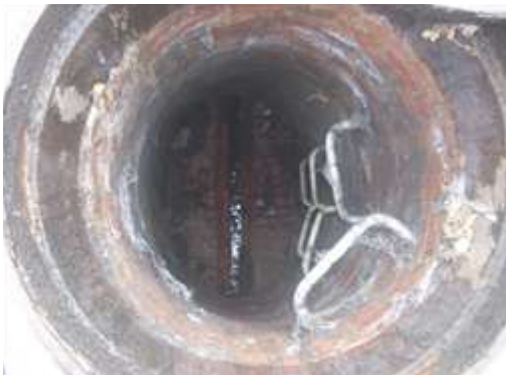
Defect 2

Corbel Material: **Brick and Concrete** ☐ Parged Type: **Concentric/Eccentric**

Condition: ☐ Sound ☐ Cracked ☐ Root Intrusion ☐ Loose Brick ☒ **Deteriorated**

corbel deteriorated

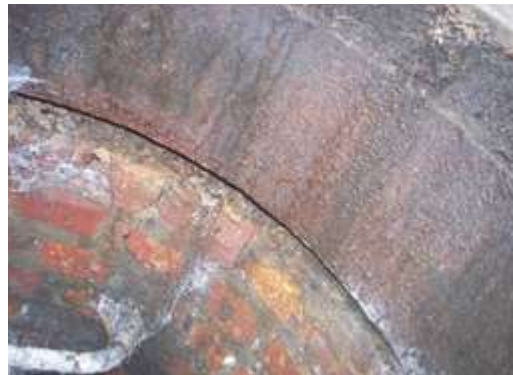
Defect 1

Chimney / Frame Adjustment ☒ Exists Material: **Brick and Concrete** ☐ Parged Height: **2** (in.)

Condition: ☐ Sound ☐ Cracked ☐ Root Intrusion ☐ Loose Brick ☒ **Deteriorated**

DETERIORATION OF CHIMNEY

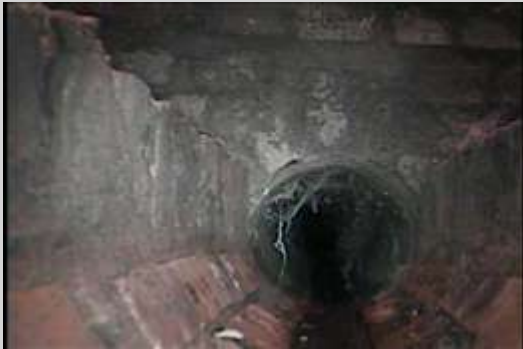
12 O'Clock Outflow

8 in. Circular Gravity Sewer
Pipe Out @ 12 O'Clock

Pipe Height: **8.4** (in.) Rod and Bar (Angled)
Pipe Material: **Clay** ☐ Pipe Lined
Invert Depth: **10.44** (ft.) Flow Characteristics: **Slow**
Deposits: ☒ None ☐ Mud ☐ Sludge ☐ Debris ☐ Grease
Silt Depth: (in.) Deposits Extent:
Infiltration: **None** Pipe Seal Cond: **Sound**

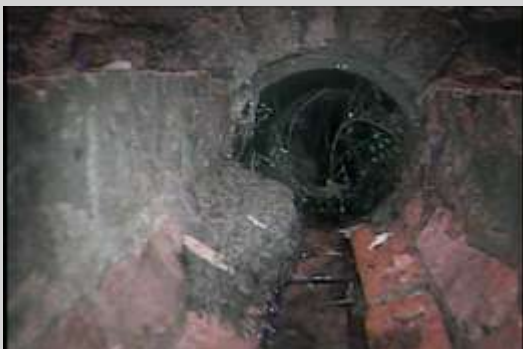
6 O'Clock Inflow

8 in. Circular Gravity Sewer
Pipe In @ 6 O'Clock

Pipe Height: **7.2** (in.) Rod and Bar (Angled)
Pipe Material: **Clay** ☐ Pipe Lined
Invert Depth: **9.81** (ft.) Flow Characteristics: **Slow**
Deposits: ☒ None ☐ Mud ☐ Sludge ☐ Debris ☐ Grease
Silt Depth: **2** (in.) Deposits Extent:
Infiltration: **None** Pipe Seal Cond: **Roots**
